Applies To: **1998 Accord LEV M/T LX and EX** – ALL U.S. Built (VIN begins with 1HG) **February 26, 2004**
1999 Accord LEV M/T LX and EX – From VIN 1HGCG31..XA000001 thru 1HGCG31..XA013356
– From VIN 1HGCG55..XA000001 thru 1HGCG55..XA090325
– From VIN JHMCG55..XC000001 thru JHMCG55..XC043602

Product Update: Throttle Body Air Bleed Screw

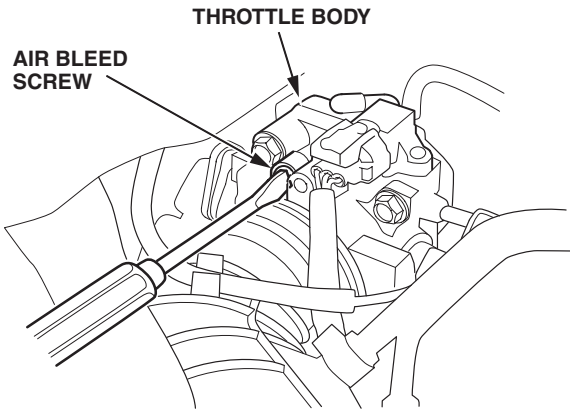
During some driving conditions, the vehicle may emit a level of emissions that exceeds state and federal emissions standards.

1. If needed, expose the air bleed screw by removing the material covering it.

2. Turn the air bleed screw clockwise until it's fully seated. Do not overtighten the screw.
3. Turn the air bleed screw counterclockwise two full turns.
4. Do the idle learn procedure:
   - Make sure all electrical items (A/C, audio unit, lights, etc.) are off, then start the engine.
   - Let the engine reach normal operating temperature (the cooling fans cycle twice).
   - Let the engine idle (throttle fully closed) for 10 minutes.
5. Center-punch a completion mark above the 10th character of the engine compartment VIN.

Center-punch here.
